Getting a grip on non-piggable lines

By Peter van Beugen, Pipesurvey International, Zwijndrecht, Netherlands

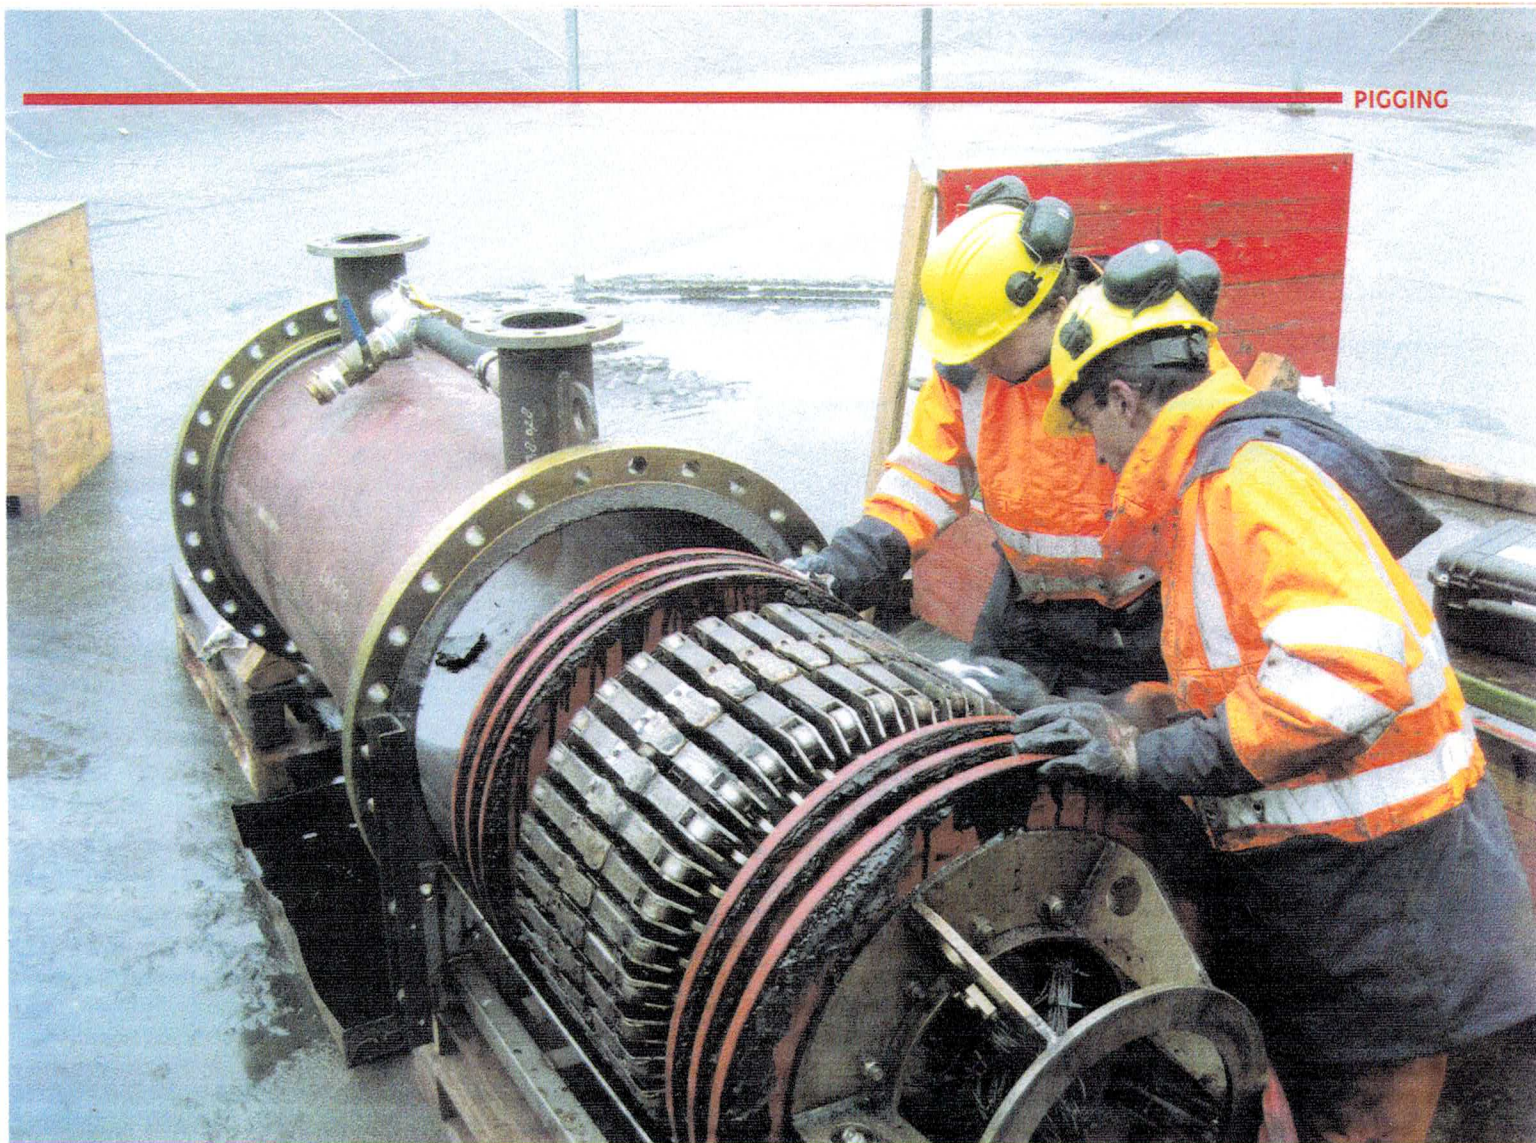
A 30 inch bi-directional tool with temporary pipe spool upon completion of first inspection run.

The aboveground section of the pipeline had flanged spools which could be taken out relatively easily. A temporary pipe spool was created that could act as a temporary pig trap. The spool is complete with connections, flanges and attached piping and hoses to operate in both flow directions. A temporary

pump spread was brought to place to create flow in the line from the storage tanks towards the pumping house. The pump of the pumping house would be used to create the reverse flow and move the tool back towards the temporary pumping station.

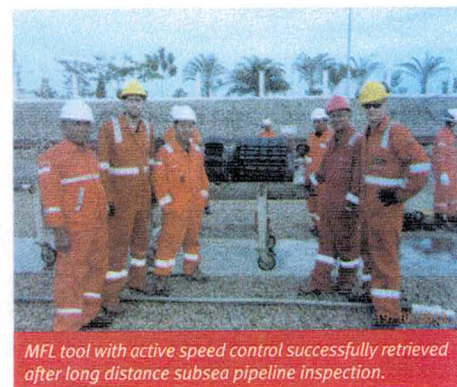
MFL tool with active speed control successfully retrieved after long distance subsea pipeline inspection.

In order to move the tool through a high production pipeline, an active speed control unit was designed which regulates the amount of gas bypass through the tool while moving through the pipeline. Again, a trial set-up was built in order to investigate the behaviour of the tool at various speeds and the computer unit of the speed control device tested. The bypass valve system was also tested in static and dynamic conditions in order to get a close picture of the system in the pipeline. Finally, the fail-safe mechanism was tested in order to ensure that, whatever the condition of the tool and the gas flow, the inspection tool would always travel to the receiving station.

The high resolution MFL tool with inertial navigation system and active speed control unit (ASCU) was brought to the field to inspect a 28 inch, 250 km subsea gas transmission line. The operation for the ASCU was evaluated upon completion of the pig run and the tool had travelled at the pre-set conditions of 3-4 m/s in a gas line, with velocity of 5 m/s at launch, heading towards 9.5 m/s at the receiving end.
